TECHNICAL REPORT ARLCD-TR-85003

**INVESTIGATION OF DAMAGED LANDS OF M185 CANNON
MOUNTED ON THE 155-MM M109A1 HOWITZER**

JUNE 1985

U.S. ARMY ARMAMENT RESEARCH AND DEVELOPMENT CENTER

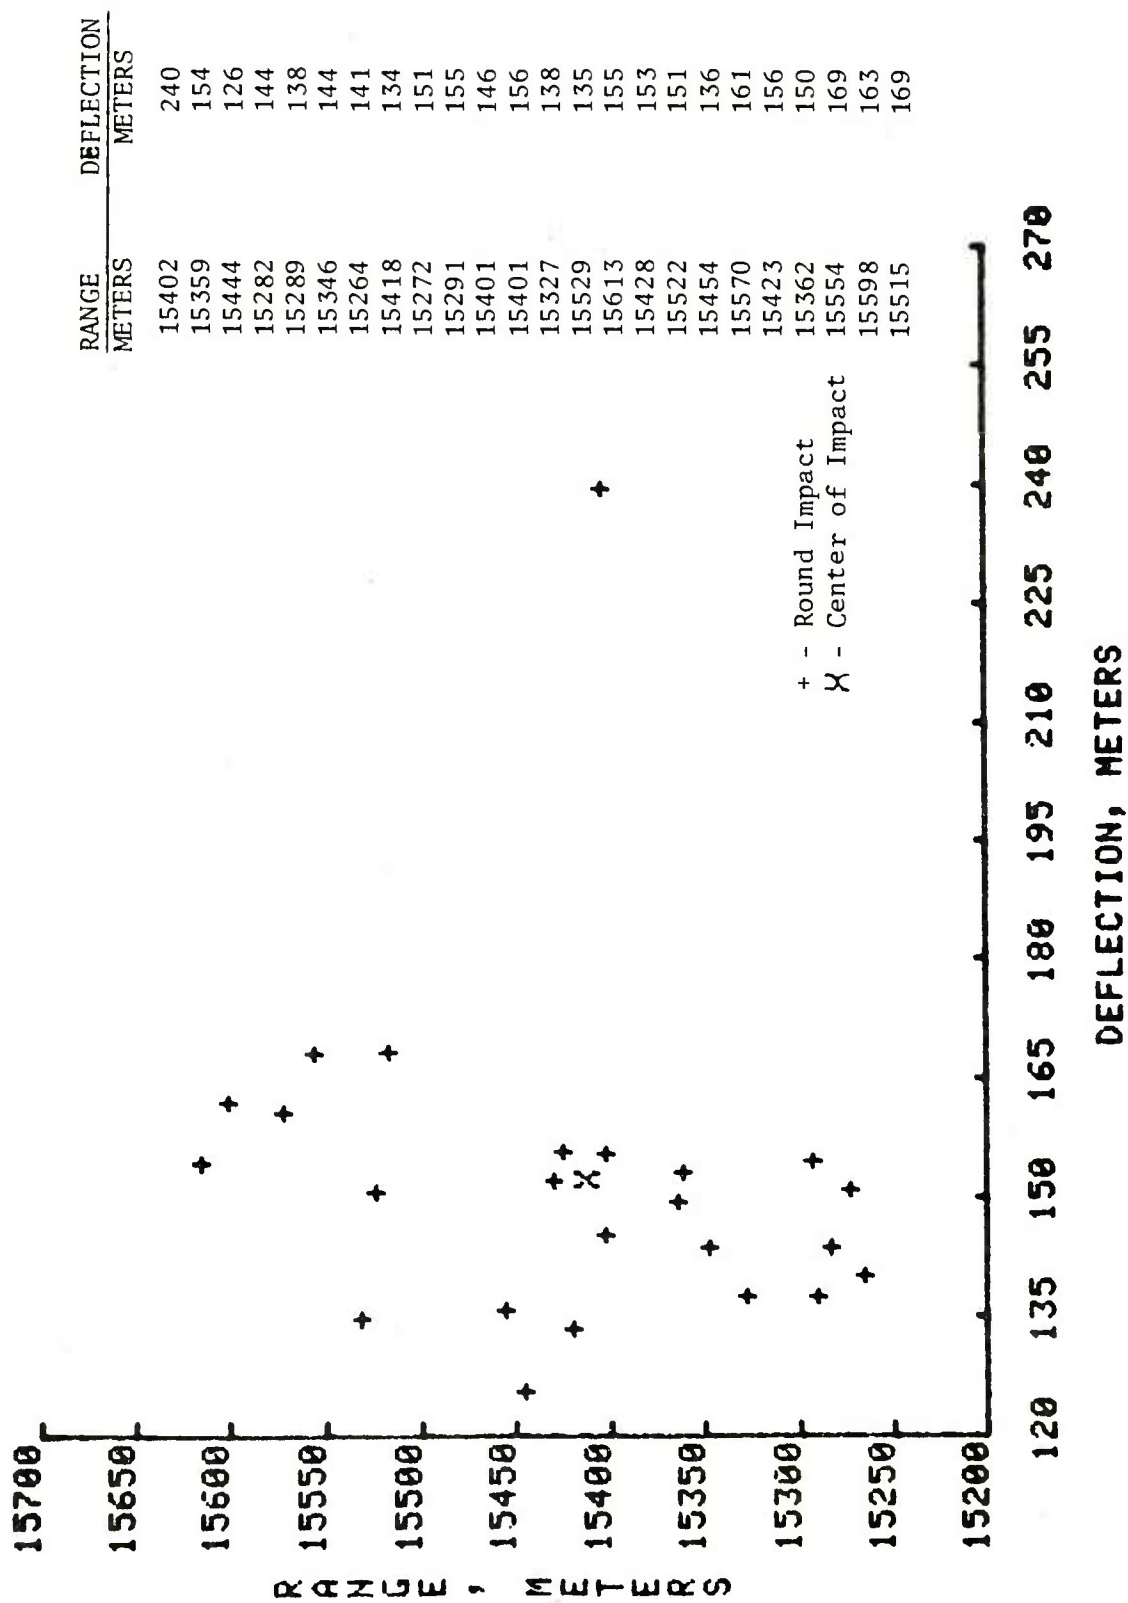
Figure 32. Range firings with damaged tube S/N 25460-M549 projectile, rocket off

unavailability of a firing table for an M549 projectile with rocket off, fired from an M185 cannon, mounted on an M109 SPH. The range and deflection probable errors from the test were greater than the 45 m and 9 m, respectively, predicted by the BRL data at 15,000 m (table 21). However, the validity of the correlation between sets of data is uncertain so the difference in values is not quantitative. A plot of the M549A1 range and deflection data is given in figure 32.
